# Corrected Figure 1: Paul McMahon VK3DIP Wideband Return Loss Bridge

*Amateur Radio*, August 2008, page 11

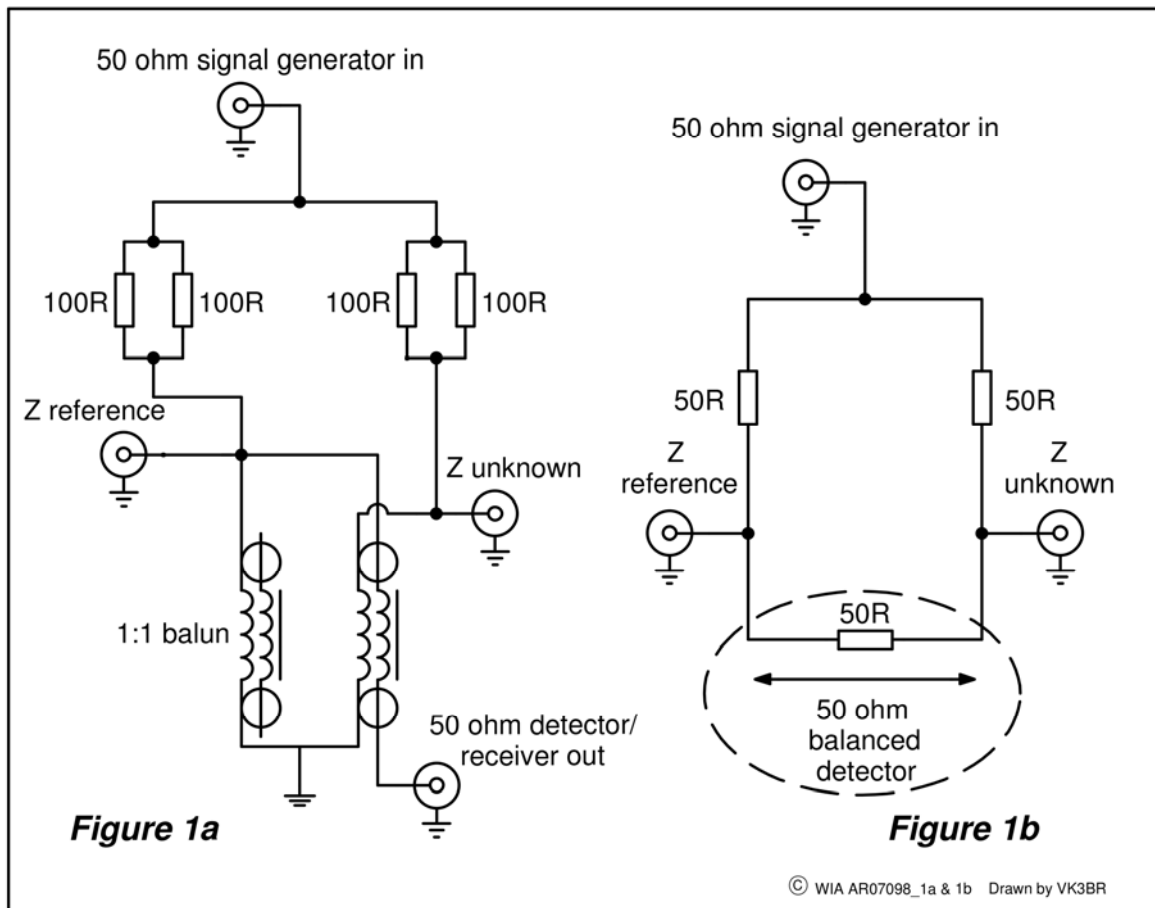
Note that the 4 wires close to the "Z reference" connector should be connected!
